INVESTIGATIONS OF BARREL BORE WEARING MECHANISM

In this paper the investigation results of a barrel bore wearing are presented. Analysis of alterations occurring in the upper layer of the barrel is carried out and the causes as well as the mechanism of the barrel bore wearing are found out.

2. Investigations of the upper layer state of barrel bore after firing

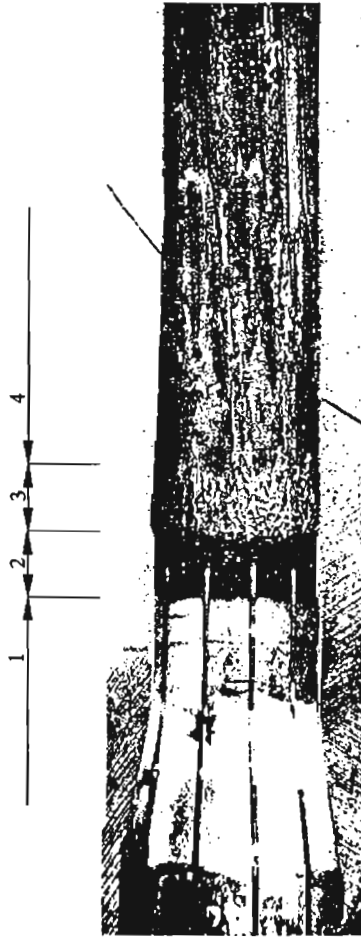
Fig. 1. Barrel bore with indicated wearing zones

of wearing along the barrel bore, four of which are shown in Fig.1.

The first zone occupies the cartridge chamber region. The bore surface in this zone is coated by the glossy chromium without the apparent altering of the surface shape.

The second zone occupies the region of resting position of the projectile rotating ring. It is characterized by the dark surface with no signs of damages.

About 6 mm wide, the third zone begins just after the front edge of the rotating ring. In this zone are apparently visible, with the unaided eye, dimensional changes of the bore as well as surface damages in the form of longitudinal furrows and the cracking net. The bore surface is pitted, one can notice the complete lack of the rifling contour in this zone. The chromium layer does not appear.

The fourth zone is about 60 mm long. There exist the apparent wearing effects in the form of rifling contour destruction. The field and furrow destruction decreases in the direction of barrel outlet. Moreover, on the uncovered bore surface the cracking net and large losses of chromium layer are visible. In the outlet direction of this zone the regions coated by copper layer are visible.

In the fifth zone there do not occur the mechanical effects of the surface damage.

In the sixth zone (around the barrel outlet) the bore surface is coated by the glossy chromium.

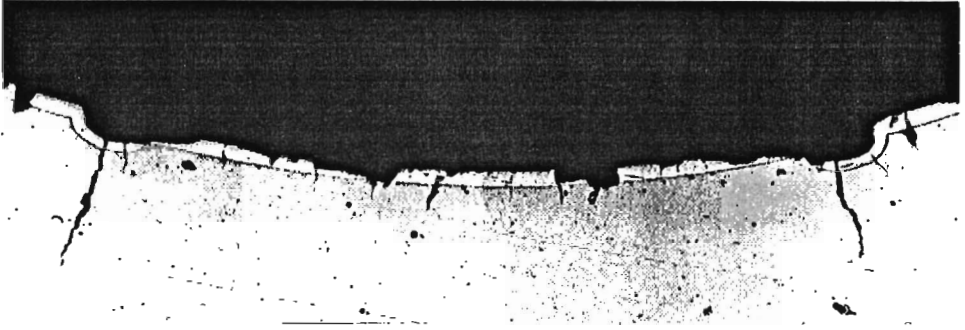
Fig. 2. Barrel cross-section in the second zone (magn. 20 \times)

In the second zone numerous crackings and splinters of chromium occur. Some of these crackings penetrate the material bulk. Particularly deep crackings occur in the Raveli's grooves (Fig.2).

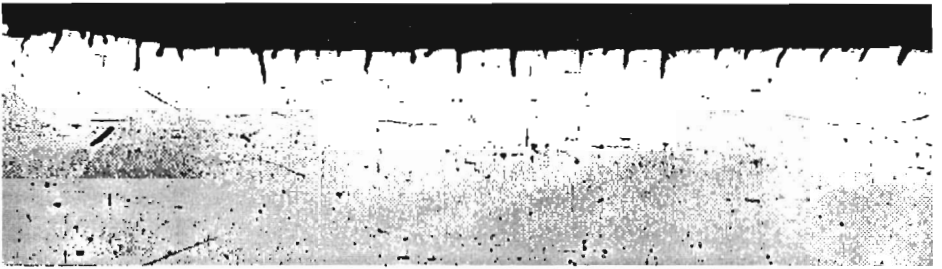
Fig. 3. Barrel coaxial section in the third zone (magn. 20 \times)

In the third zone the chromium layer is missed and numerous material crackings occur, visible in the longitudinal (Fig.3), as well as, lateral cross-sections (Fig.4). Crackings in the region of largest damage of the barrel bore appear to be normal to the inner surface of it, however, in the regions closer to the barrel outlet they appear to be inclined towards the projectile motion.

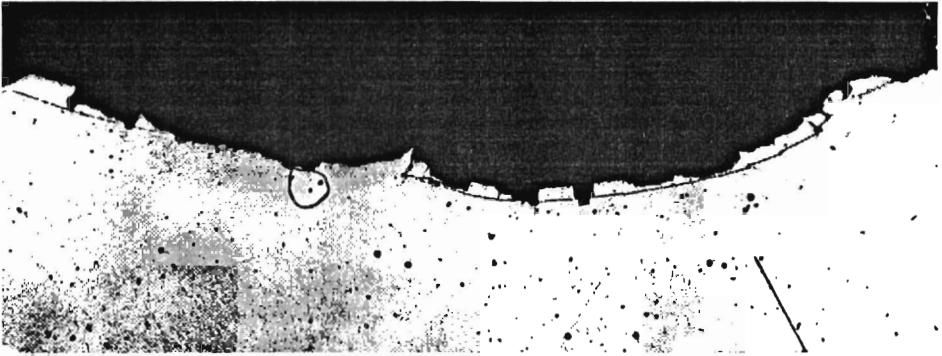
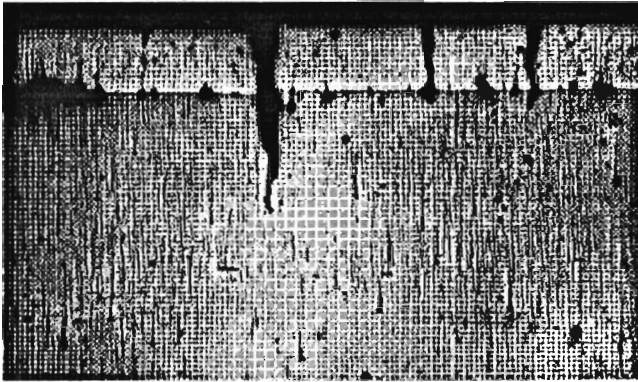
In the fourth zone the numerous crackings of the chromium layer and uncoated base occur. In most cases under the crackings through the chromium layer, the surface crackings of the barrel material occur. It is possible to find the numerous splinters of the chromium layer (Fig.5 and Fig.6). Considering the surface, they are smaller in grooves and larger in the rifling contour fields. Some fragments of the field contours are completely free from the chromium

Fig. 5. Barrel cross-section in the fourth zone (magn. 20x)

Fig. 6. Barrel cross-section in the fourth zone (magn. 100x)

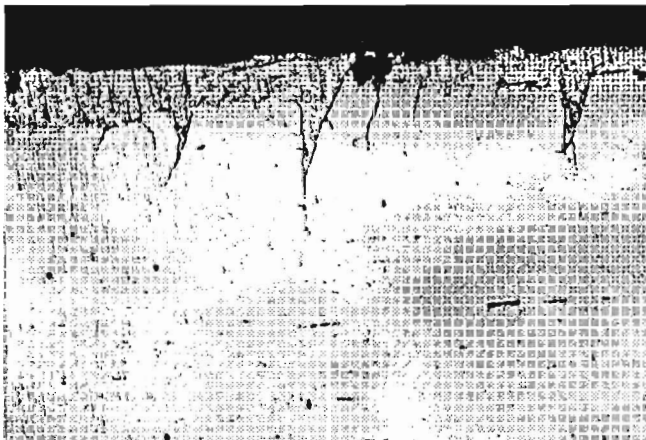
Fig. 7. Barrel coaxial section in the fourth zone – visible is a copper layer on the surface (magn. 100x)

layer. Moreover, in the regions of spalled chromium the copper layer occurs, which also fills the local crackings of the base (Fig.7). The way of crack filling by copper as well as the chromium splinters appearance show that copper penetrates the slots while being in the liquid state. It is also supported by the copper structure presented in Fig.8.

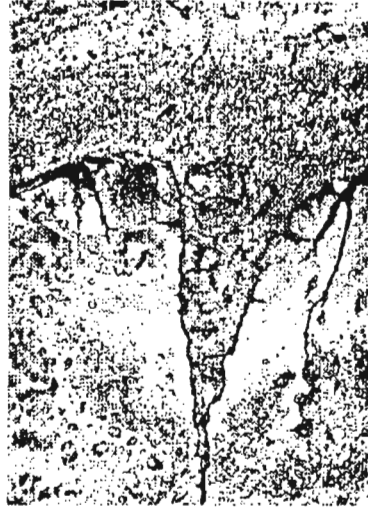
Fig. 8. Barrel cross-section in the fourth zone – visible is copper filling the crackings (magn. 500 \times etch. Mi15Cu)

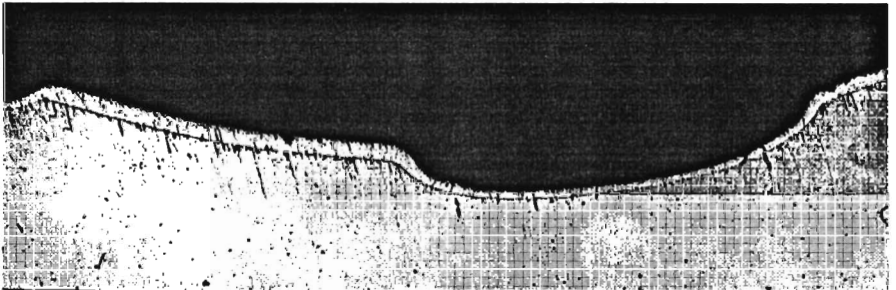
Fig. 9. Barrel cross-section in the fifth zone (magn. 20 \times)

In the fifth zone the chromium layer was not destroyed except the small number of crackings (Fig.9).

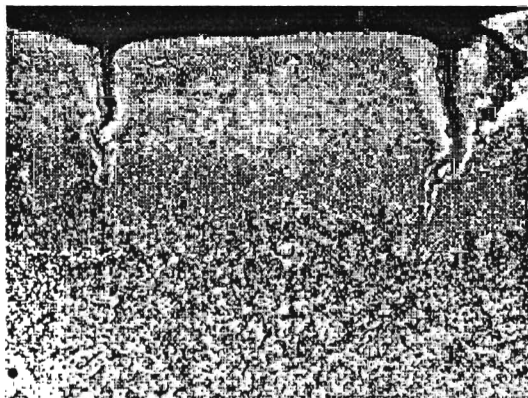
Fig. 10. A metallographical structure occurring in the third zone (magn. 500 \times etch. Nital)

In the third zone, at the surface, there were identified four different structures (Fig.9). At the surface, up to the depth of 0.01 mm a white etch resistant structure with inclusions of the form of carbides occurs. Low hardness ($245 \mu\text{HV}$) in this region suggests that it is the ferrite structure. The 0.04 mm thick next layer is etch resistant and has hardness of $1080 \mu\text{HV}$. It indicates that in this region the martensitic structure occurs. The successive darker layer has the sorbitic structure with hardness of $458 \div 301 \mu\text{HV}$. Microhardness distribution in the layer is shown in Fig.11.

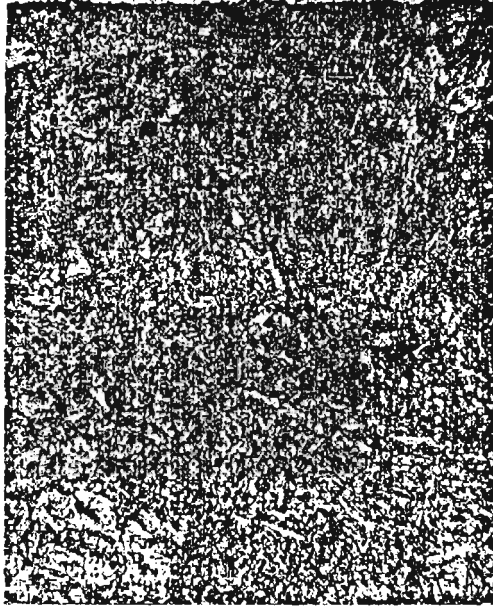
In the fourth zone there were found no essential structural differences between the surface layer of the barrel and the base in the regions of the chromium presence (Fig.12). In the regions of chromium splintering the surface martensitic layer is visible (Fig.13), which is very much a like the third zone.

Fig. 12. Metallographical structure in the fourth zone (magn. 500× etch Nital)
